# Manhole Inspection Summary

Manhole # S43II\_014MH

Insp Date: **4/25/08 8:14 AM**

**Location** Address: **Federal St**

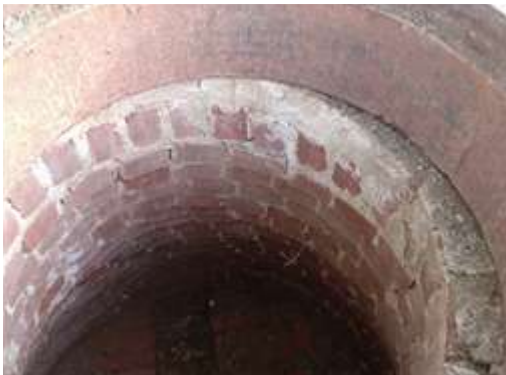
Defect 2

Offset: **3** (in.)

☒ **Leaks**

Frame Leaks

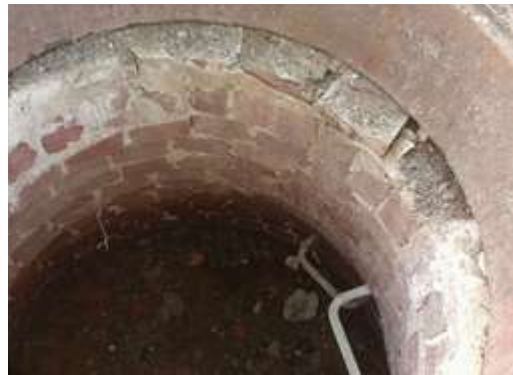
Defect 1

☒ **Loose Brick**

☒ **Deteriorated**

☒ **Mortar**

Deterioration

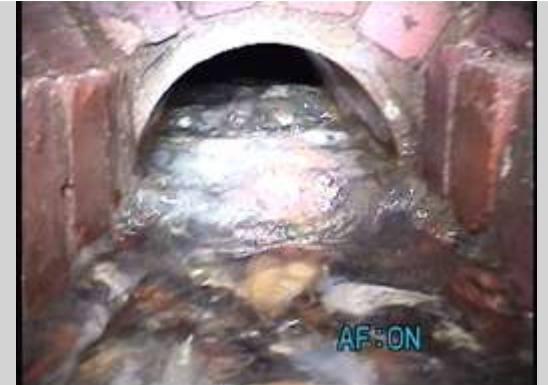
8 in. Circular Gravity Sewer  
Pipe Out @ 12 O'Clock

12 O'Clock Outflow

Pipe Height: **8.4** (in.) Rod and Bar (Angled)  
Pipe Material: **Clay** ☐ Pipe Lined  
Invert Depth: **6.30** (ft.) Flow Characteristics: **Fast**  
Deposits: ☐ None ☐ Mud ☐ Sludge ☒ **Debris** ☐ Grease  
Silt Depth: **4** (in.) Deposits Extent: **Medium**  
Infiltration: **None** Pipe Seal Cond: **Sound**

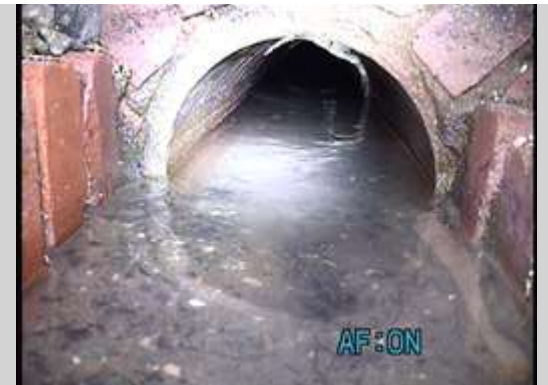
8 in. Circular Gravity Sewer  
Pipe In @ 9 O'Clock

9 O'Clock Inflow

Pipe Height: **8.4** (in.) Rod and Bar (Angled)  
Pipe Material: **Clay** ☐ Pipe Lined  
Invert Depth: **6.20** (ft.) Flow Characteristics: **Fast**  
Deposits: ☒ **None** ☐ Mud ☐ Sludge ☐ Debris ☐ Grease  
Silt Depth: (in.) Deposits Extent:  
Infiltration: **None** Pipe Seal Cond: **Sound**
